**CEC Bridges Partnership**  
 Powderhall Footbridge No. 2  
 HY623/211

**Our reference:** 100103506-012-TN11      **Your reference:** tbc

**Subject:** Failure of nodes in main span top chord

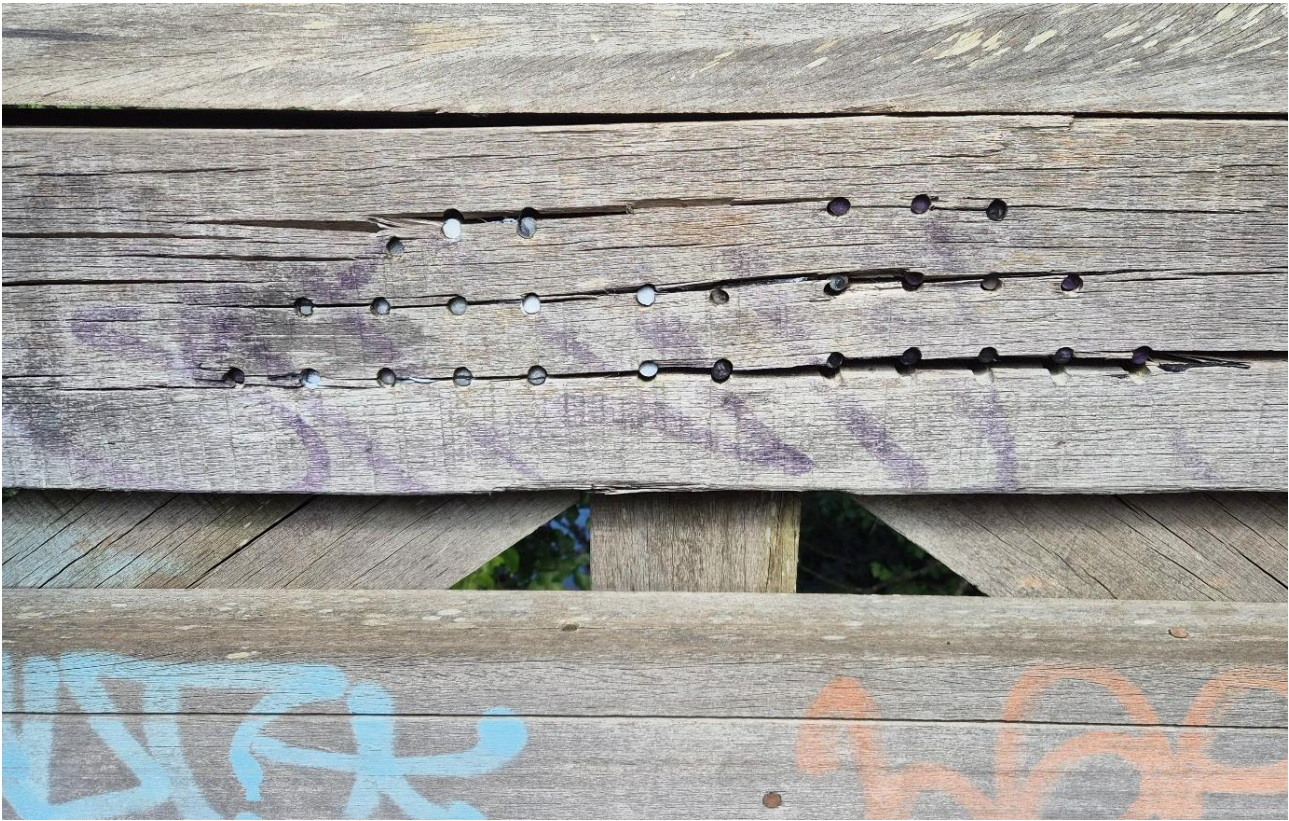
Figure 2: Top chord node – internal view.
