# CEC Bridges Partnership

Powderhall Footbridge No. 2  
 HY623/211

| <b>Our reference:</b> | 100103506-012-TN11 | <b>Your reference:</b> | tbc |
| <b>Subject:</b> | Failure of nodes in main span top chord | | |

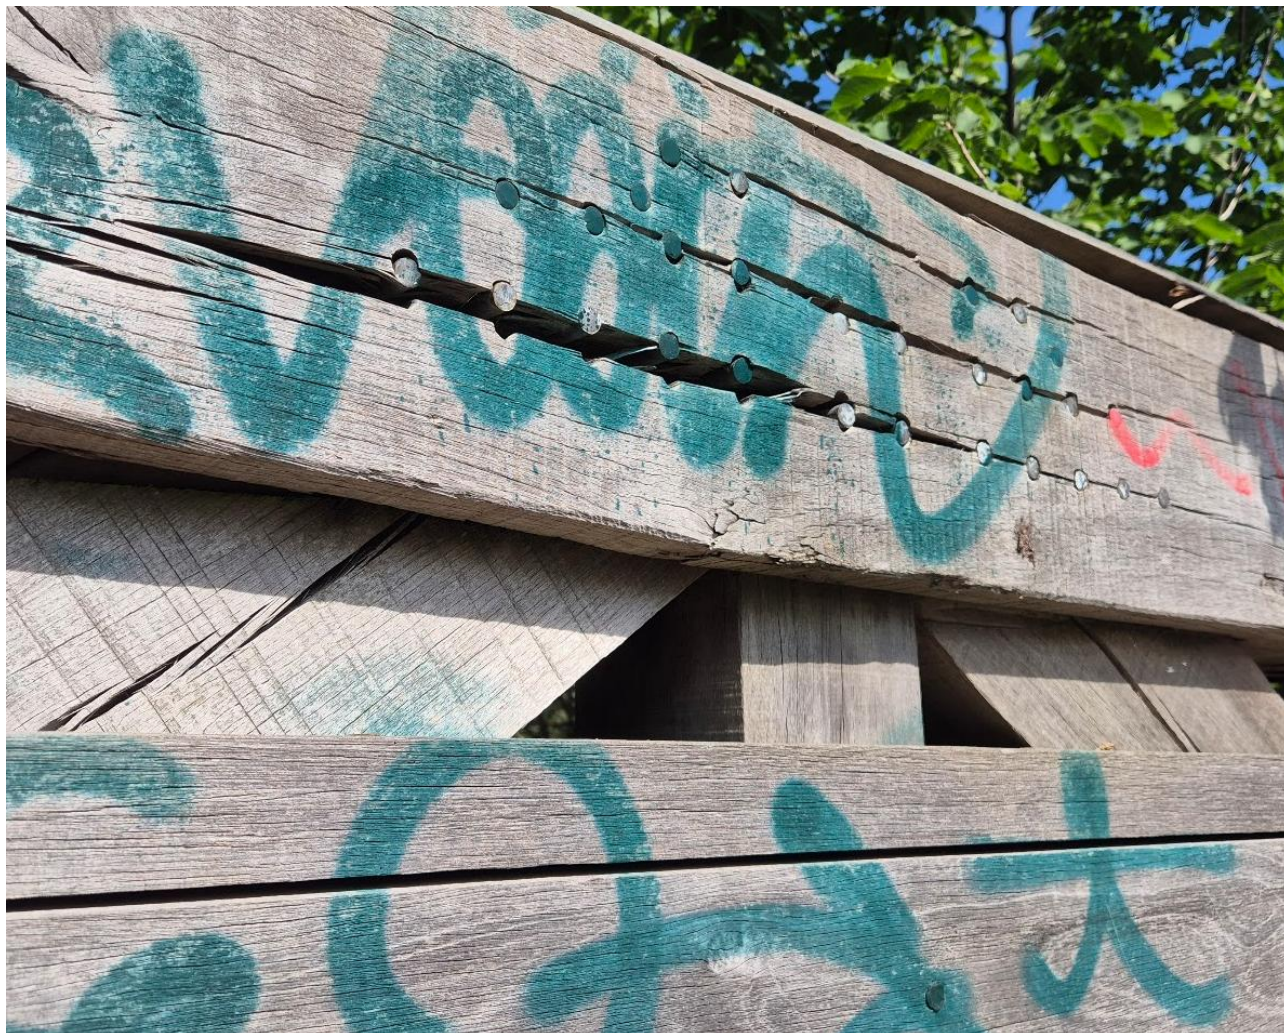
1. The nodes in the top chord (mortise and tenon joints with steel dowels) which are readily inspectable from the footpath exhibit signs of splitting along the grain of the timber in the top chord.

2. The main span is approximately twice the length of the two side spans. The nodes towards the end of this span, which must transmit the highest forces between diagonal members, are detailed with the same dowel arrangement as the other nodes and exhibit the most serious splitting.

3. The severity of the splitting at the most highly stressed locations indicates that the connection has failed to perform as the designer intended.
4. Failure of the node may be possible at any time, either due to an incidence of high live loading, environmental actions such as unusually hot weather, or under dead load after further deterioration. None of these risks are currently controlled.

**Figure 1: Top chord node – severe splitting in all members. Note right-hand diagonal displacing up and left-hand diagonal pulling down**

## **To ensure public safety, we recommend a closure of the footbridge to the public is implemented urgently.**

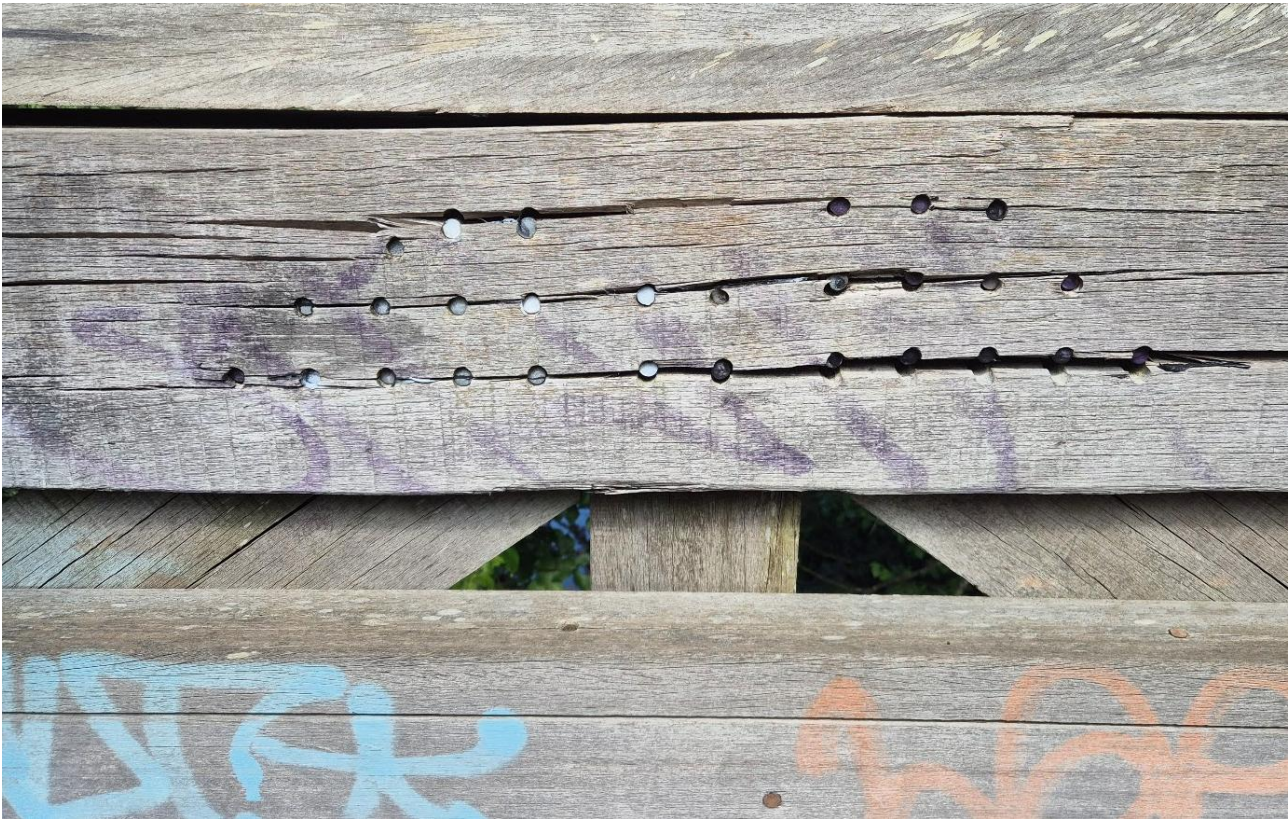
Figure 2: Top chord node – internal view.

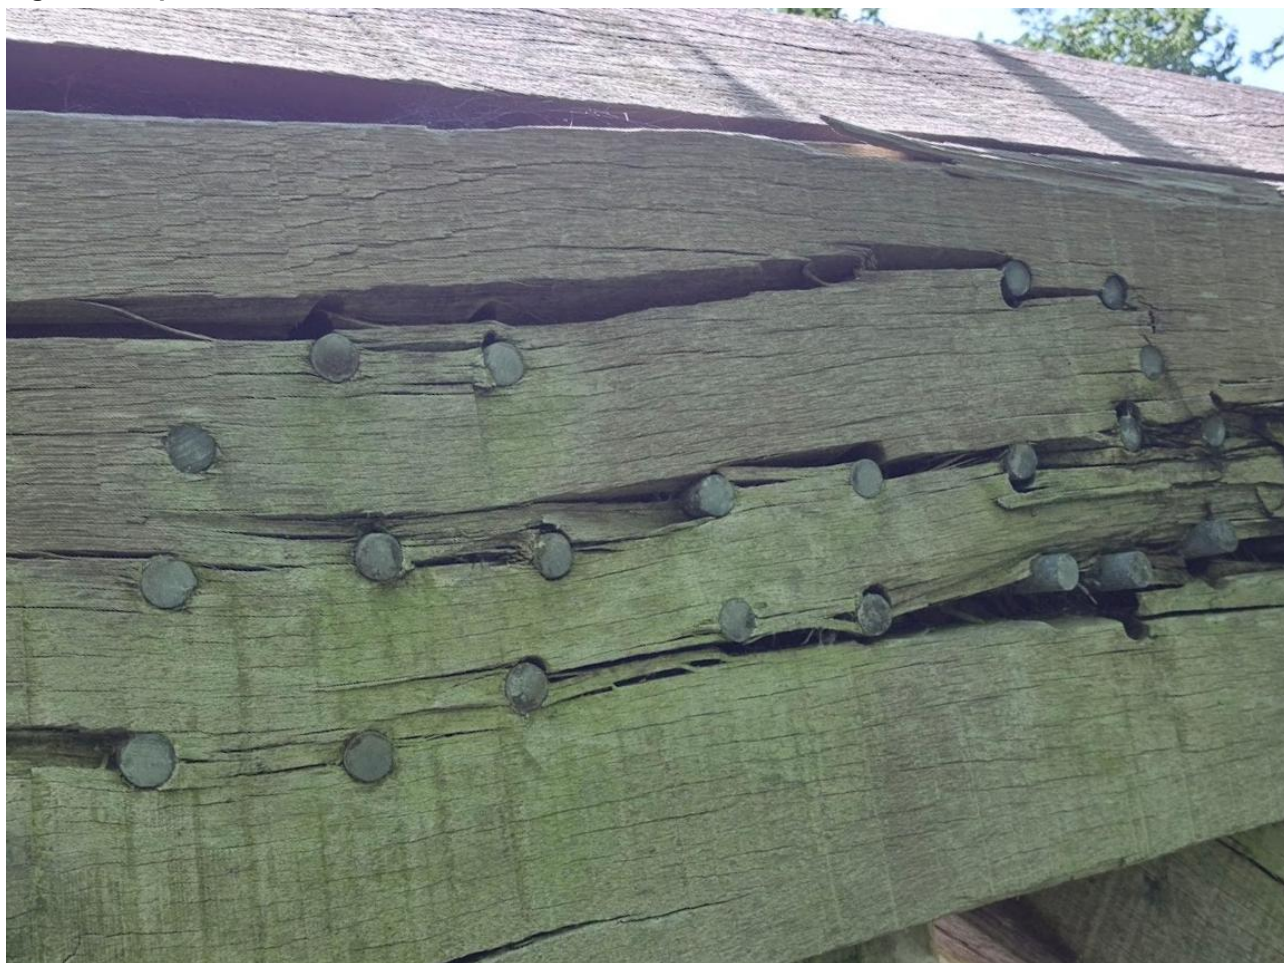
**Figure 3: Top chord node – external view**
